CIA/PIR-77043

CIA IMAGERY ANALYSIS DIVISION

PI-TSUN MILITARY COMPLEX

PI-TSUN, CHINA

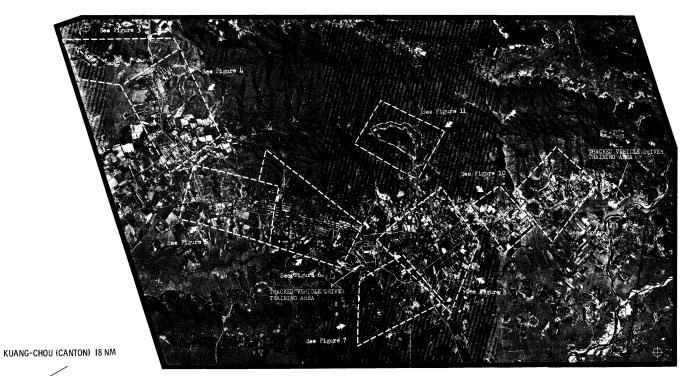
Figure 2
Approved For Release 2003/05/14 : CIA-RDP78T05161A001400010022-0

The Pi-tsun Military Complex is located approximately 18 nm north of Kuang-chou (Canton) and 2 nm northwest of the town of Pi-tsun at 22 23N-113 08E. This complex is composed of several military installations (See Figure 2) which are in close proximity to each other. This complex is probably capable of housing a Chinese Communist Army Artillery Division.

All photographs in this study are from						
with the exception of Figure 2 which utilizes coverage from						
Although this photography is two years old it gives						
excellent coverage of the equipment and the entire complex.

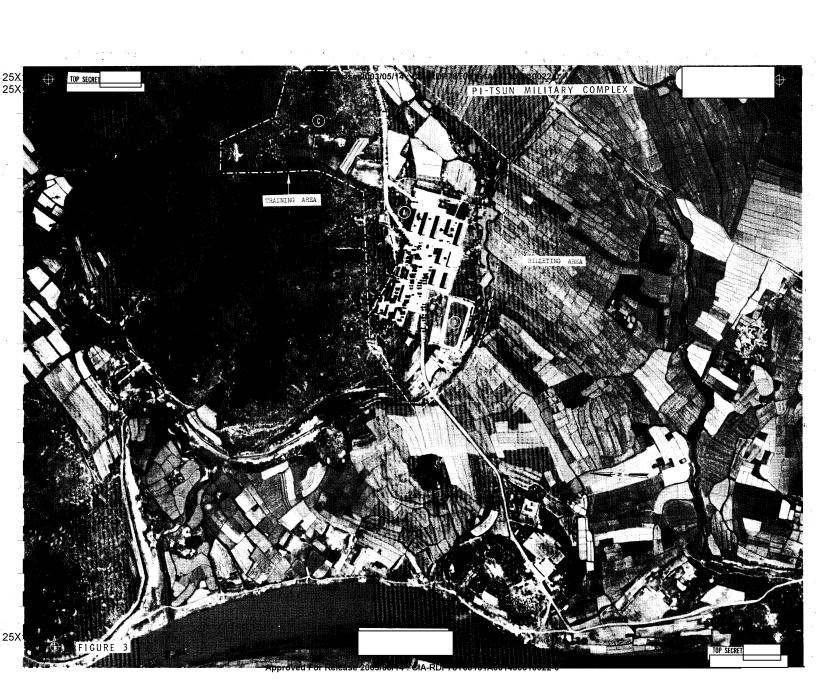
FUNCTIONAL ANALYSIS (See Figure 3)

- A. Probable Billeting Area
 - 18 Probable barracks
 - 1 Probable messhall
 - 5 Probable support buildings
- B. Probable Athletic Field
 - l Possible basketball court
 - 1 Probable running track
- C. Training Area
 - l Probable subcaliber firing range

The training area is located on the south slope of the small hill located at the rear of the probable billeting area. Photography reveals extensive recent ground scarring and trenching.

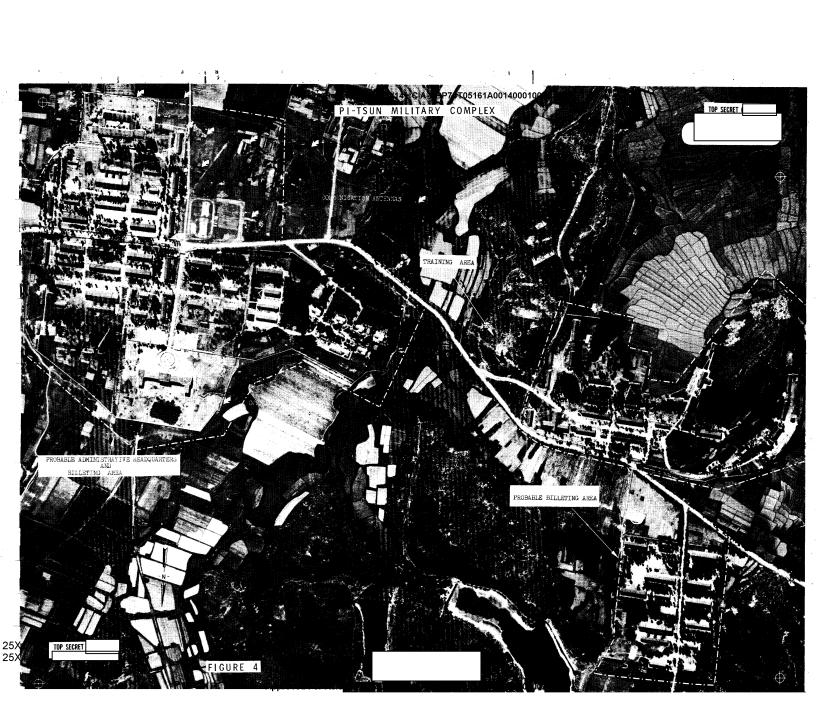
FUNCTIONAL ANALYSIS (See Figure 4)

Probable Administrative Headquarters and Billeting Area

- 1 Probable administrative headquarters building
- 27 Probable barracks
- 3 Probable messhalls
- 14 Probable support buildings
- 1 Probable communications building
 - Numerous antennas are located adjacent to this building.
 - (b) Separate security fence surrounds this area.
- 2 Basketball courts and a running track

- 2 Probable administration buildings
- 12 Probable barracks
- 1 Probable messhall
- 16 Probable support buildings

- 9 Probable barracks
- 1 Probable messhall
- 8 Probable support buildings

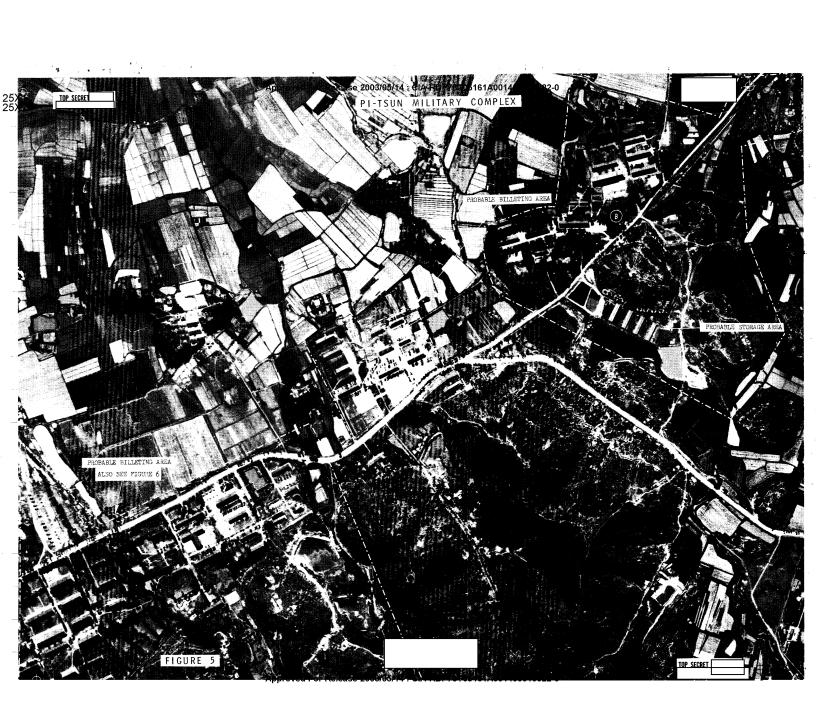
FUNCTIONAL ANALYSIS (See Figure 5)

- 10 Probable barracks
- 2 Probable support buildings

- 7 Probable barracks
- 1 Probable messhall
- 4 Probable storage buildings
- 12 Probable support buildings

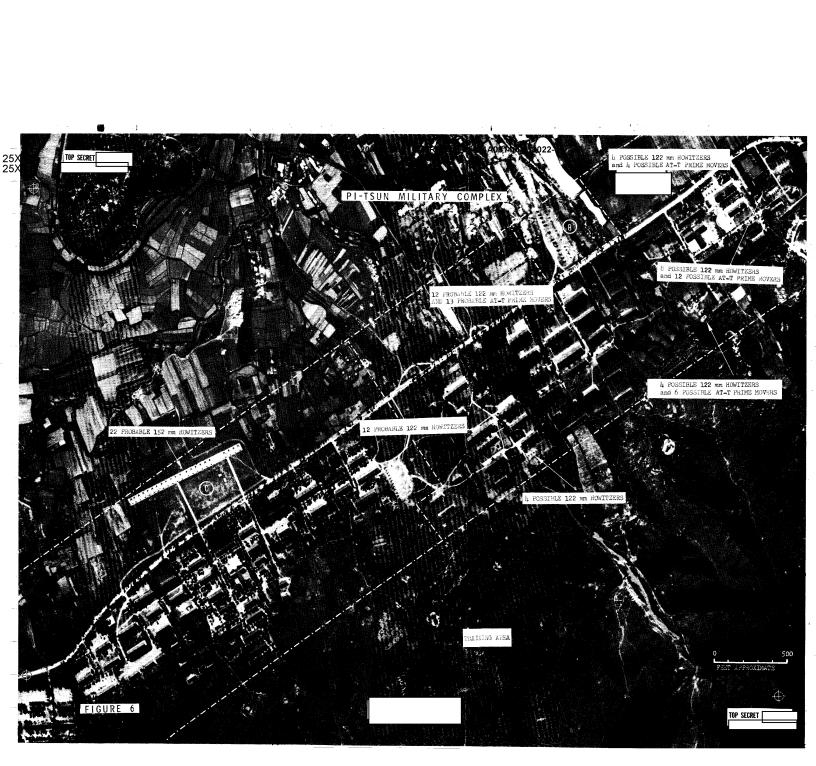
Approved For Release 2003/06/14 : CIA-RDP78T05161A001400010022-0	2:
	CIA/PIR-77043	
	CIA IMAGERY ANALYSIS DIVISION	
	PI-TSUN MILITARY COMPLEX	
FUNCTION	MAL ANALYSIS (See Figure 6)	
Α.	Probable Billeting Area	,
	Probable barracks Probable administration buildings Probable messhalls Probable support buildings Probable vehicle/equipment storage buildings	
	Building No. 1. Building No. 2. 155' X 40' Building No. 3. 165' X 40' Building No. 4. 145' X 30' Building No. 5. 140' X 30' Building No. 6. 100' X 30' Building No. 7. 40' X 15'	
	Sixteen possible 122 mm howitzers and 6 possible AT-T prime movers are observed on coverage.	2
В.	Artillery Park	
	Twelve probable 122 mm howitzers and 13 probable AT-T prime movers are observed on coverage.

C.	Probable Billeting Area	,
	Probable barracks Probable administration buildings Probable messhalls Probable support buildings	
	Twenty-two probable 152 mm howitzers and twelve probable 122 mm howitzers are observed on coverage.	2
	The artillery pad on which the probable 152 mm howitzers are located was not active in However, (See Figure 6) the area shows a high degree of activity. The coverage (See Figure 2) indicates that the same area was turned into a possible driver training course.	2

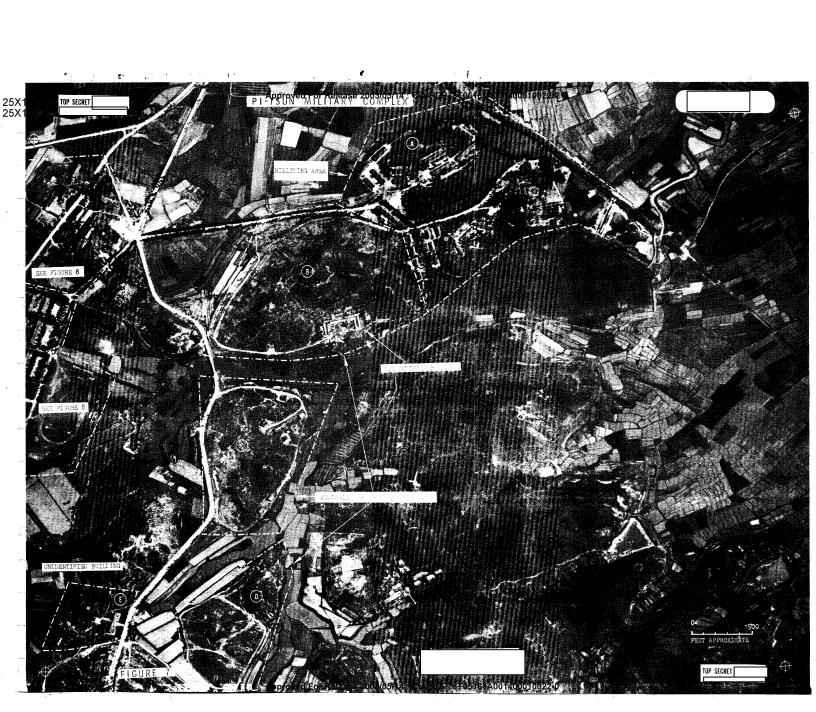
FUNCTIONAL ANALYSIS (See Figure 7)

- 24 Probable barracks
 - 1 Probable messhall
 - 9 Probable support buildings

- 2 Probable explosives storage buildings
- 1 Unidentified building
- 1 Support building

7 Probable explosives storage buildings

4 Probable explosives storage buildings

- 1 T-shaped U/I building
- 2 Support buildings

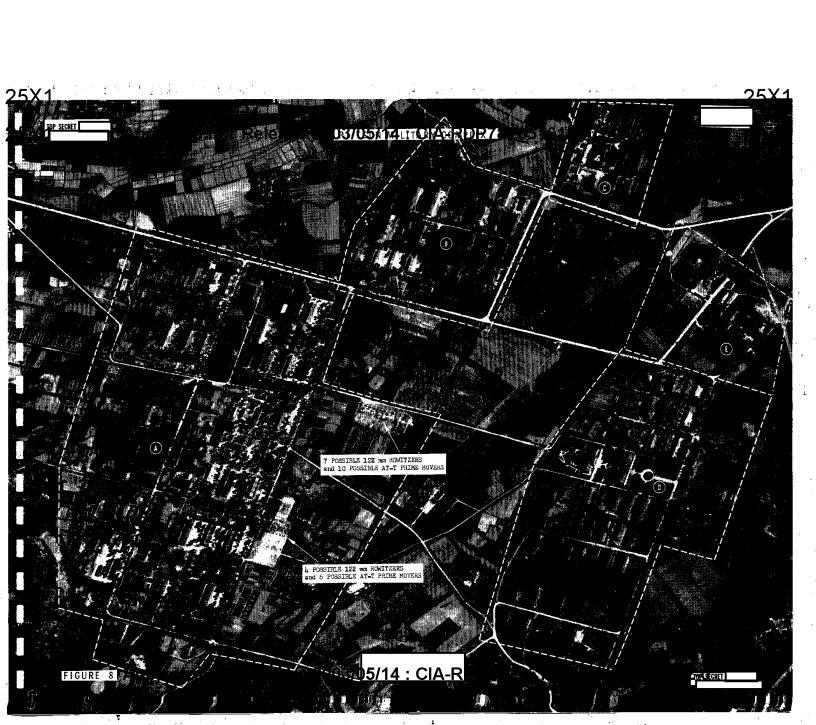
FUNCTIONAL ANALYSIS (See Figure 8)

- 3 Probable administration buildings
- 45 Probable barracks
- 4 Probable messhalls
- 44 Probable support buildings

Eleven possible 122 mm howitzers and 16 possible AT-T movers are observed on coverage.

- 13 Probable barracks
- l Messhall
- 18 Probable support buildings

- 8 Probable barracks
- 1 Probable messhall
- 8 Probable support buildings

- 2 Probable administration buildings
- 22 Probable barracks
- 43 Probable support buildings
- 1 Athletic field

26 Probable support buildings

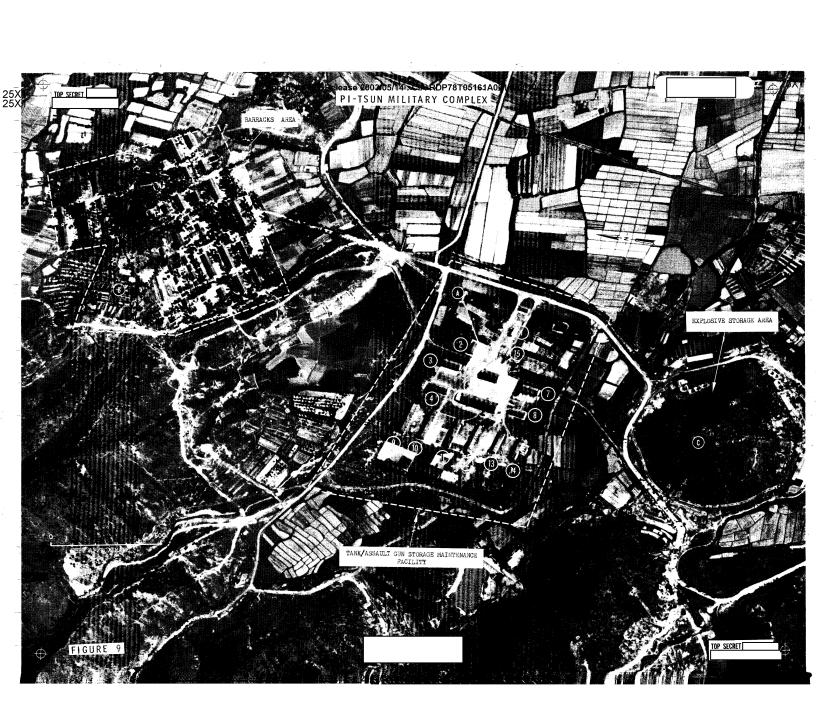
FUNCTIONAL ANALYSIS (See Figure 9)

A. Tank/Assault Gun Storage and Maintenance Area

BUILDING N	O. SIZE	FUNCTION
1.		Refueling Station
2.	100' X 25'	Vehicle Storage Shed
3.	85' X 35'	Vehicle Storage Shed
4.	85' X 35'	Vehicle Storage Shed
5.	85' X 45'	Vehicle Maintenance Building
3. 4. 5. 6.	190' X 45'	Vehicle Maintenance Building
	190' X 45'	Support Building
7. 8.		Support Building
9.	140' X 35'	Vehicle/Storage Shed
10.	140' X 35'	Vehicle/Storage Shed
11.	140' X 35'	Vehicle/Storage Shed
12.	140' X 35'	Vehicle/Storage Shed
13.	100' X 35'	Vehicle/Storage Shed
14.	100' X 35'	Vehicle/Storage Shed
15.	<u> </u>	4 Grease Racks

- l Probable administration building
- 23 Probable barracks
- 19 Probable support buildings

It is interesting to note that no tanks or assault guns have been observed in this analysis, nor have any been read out on previous missions. Possibly the tank/assault gun storage and maintenance facility is being used for the storage and maintenance of tracked prime movers.
